## Test Report

### PB300/255/10

Order: Test of the powder coating system on steel  
 ES-7105  
 RX-9006-XW  
 according to DIN 55633, corrosivity category C5-I, durability high

### Test Report PB300/256/10

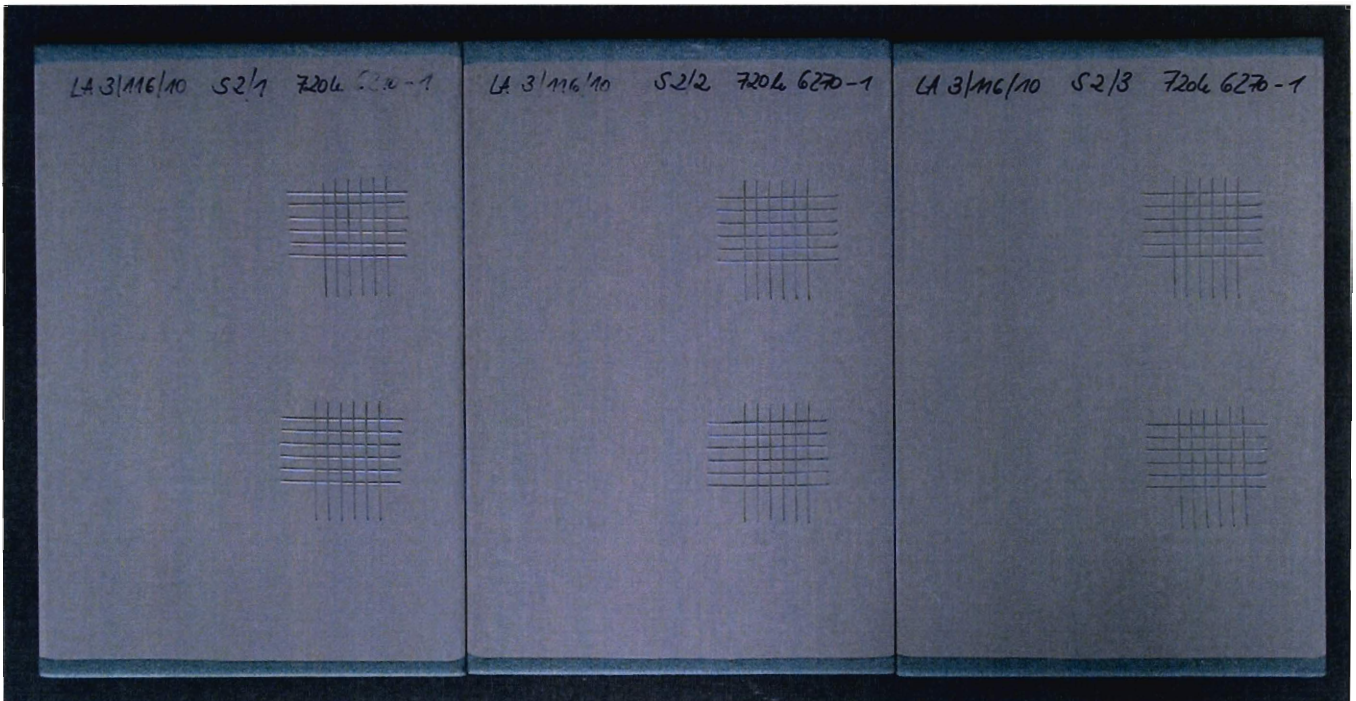
The tested powder coating system (**coating system on galvanized steel**) fulfills the requirements of ISO 12944-6 for a coating system on hot-dip galvanized steel according to corrosivity category C5-I, durability high.

Fig. 1: test specimens after loading with condensation of water
